TECHNICAL BULLETIN 141112

KEMPER 3" 1502 (STANDARD, NOT HD), 1002, 602 DETACHABLE HAMMER UNION CONNECTION

ISSUE: Kemper's commitment to product improvement has resulted in a revision to the segmented ring sets used for the 3" Detachable Hammer Union connections to further ensure that a proper connection has been made when visually checking for thread exposure.

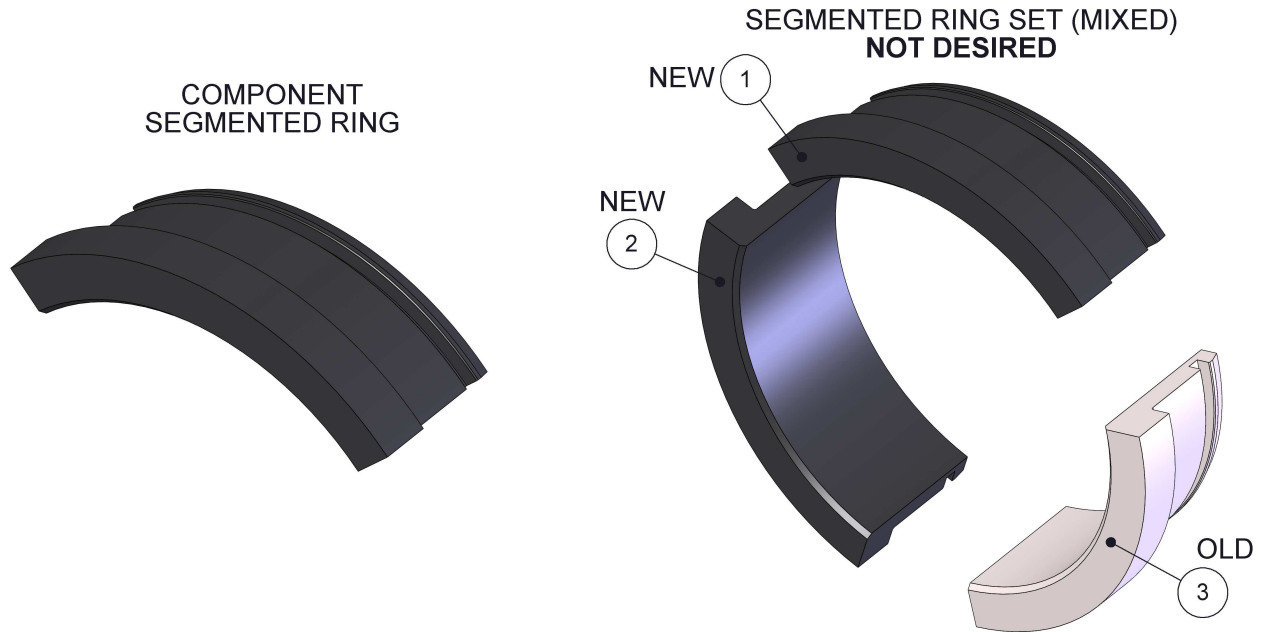
Figure 1

Kemper Valve and Fittings is publicizing the difference between old and new revision segmented ring sets in order to ensure that the component segmented rings of each set are **NOT** interchanged. A segmented ring set consists of three (3) identical component segmented rings – see Figure 1.

The **component** segmented rings must be used exclusively with their respective sets and are not interchangeable between the revisions. **All three (3) of the segmented rings in the set must be of the same revision. DO NOT USE** any combination where only two (2) of the three (3) segmented rings are the same. The new segmented rings differ from the previous revision in that the: overall length is shorter, stop step width is shorter and the **COLOR** is **BLACK** (for identification purposes) vs. the “as-machined” grey steel. It is the overall length and stop differences that make the requirement that all three (3) segmented rings be of the same revision.

ACTION: All products affected are now being supplied with the new revision of the segmented ring sets. If you have these components in-use and/or in-stock, take steps to insure that these two revisions of the segmented rings are **NOT MIXED WITHIN A HAMMER UNION CONNECTION.**

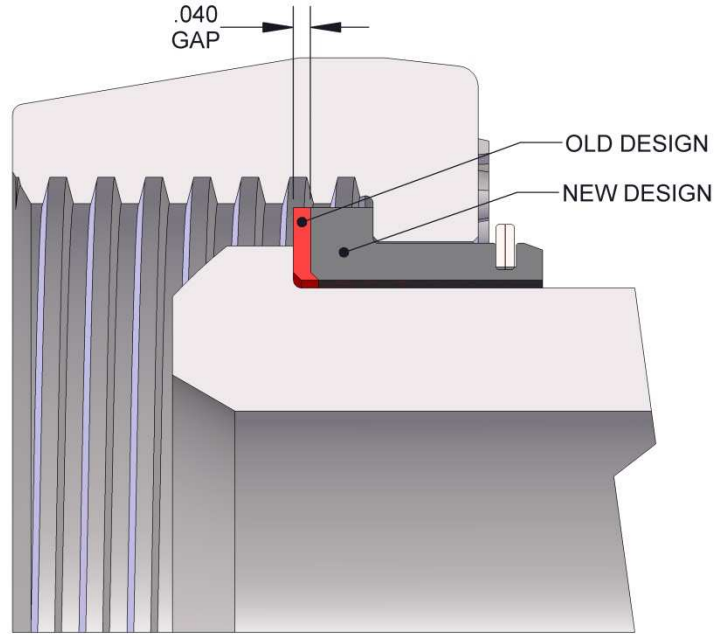
Figure 2

Mixing versions of segmented ring components would cause the nut to bottom out & stop on the old segmented ring (wider) before bottoming out & stopping on the new segmented ring (narrower). This creates a 0.040 air gap & prevents required engagement – see Figure 2.

REQUIRED ENGAGEMENT IS NOT PRESENT

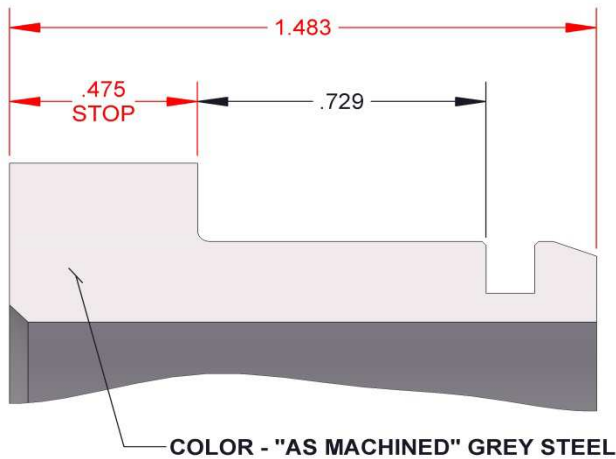
3" FIG 1502/1002/602 END CONNECTION
OLD STYLE SEGMENTED RING

OLD

- 1) Overall **LENGTH** is **1.483** inches
- 2) Stop **WIDTH** is **0.475** inches
- 3) Color is “as-machined” **GREY STEEL**

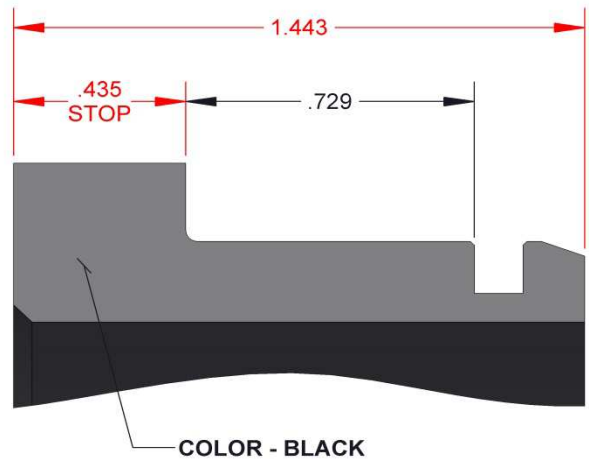
3" FIG 1502/1002/602 END CONNECTION
NEW STYLE SEGMENTED RING

NEW

- 1) Overall **LENGTH** is **1.443** inches
- 2) Stop **WIDTH** is **0.435** inches
- 3) Color is **BLACK**
